# Further Southern African experiences with the application of the IEC lightning protection standards based on their application at four major installations

**Abstract:** Over the past decade there has been a move toward the installation of integrated earthing and lightning protection systems at a variety of South African industries. This paper reviews the experiences gained from the diligent application of the International Electrotechnical Commission standards for earthing and lightning protection at four major sites. As each site had very specific interventions, these are presented in detail. It is noted that in some cases there was initial resistance to the introduction of many of these interventions, but it is concluded that these methods have had a very significant positive effect on performance of the installations.

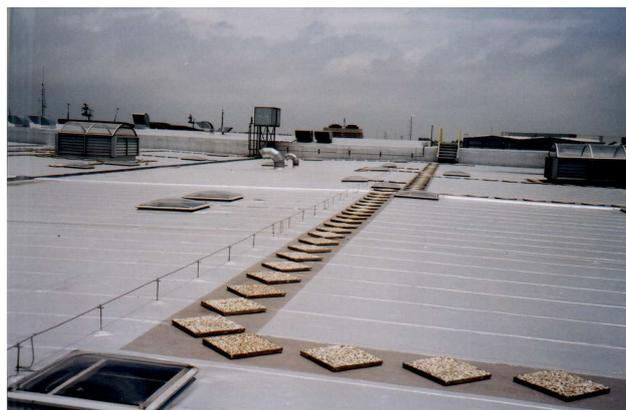
*Figure 1: Illustration of elevated horizontal air termination conductors*

- Large flat waterproofed roof areas, necessitating the use of elevated air termination conductors. Refer *Figure 1*.
- Integration of multiple earthing systems found at various installations.
- Extensive use was made of structural steelwork, from a performance, maintenance, theft and aesthetic perspective, as well as due to the constraints imposed by the existing site developments.
- A generic specification was prepared as a baseline guide for future projects and installations, in order to ensure engineering and implementation consistency.
- Internal LPS aspects were treated holistically, and included the application of EMC principles.

- The use of elevated horizontal air termination conductors for the protection of extensive flat waterproofed non-metallic roof structures.
- The integration of separate earthing systems, such as power/electronics, analogue/digital etc.
- The focus on earth electrode geometry rather than earth electrode resistance value as a design criterion.
- The importance of using inherently available natural components (such as cable support structures) to achieve equipotential bonding, and the need to ensure that these are made galvanically continuous along their length.

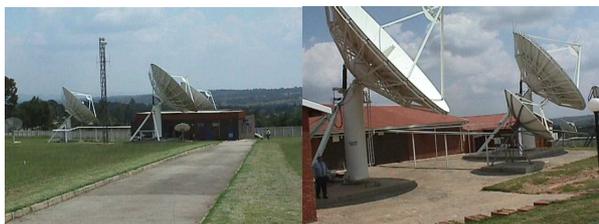
*Figure 2: Earth Station site views*

**Description of the site:** The site is the main earth station for a national radio and television broadcaster. The site includes Ku and C-band earth stations as well as a control room. The main headquarters office block is located at the same site. Refer *Figure 2*.

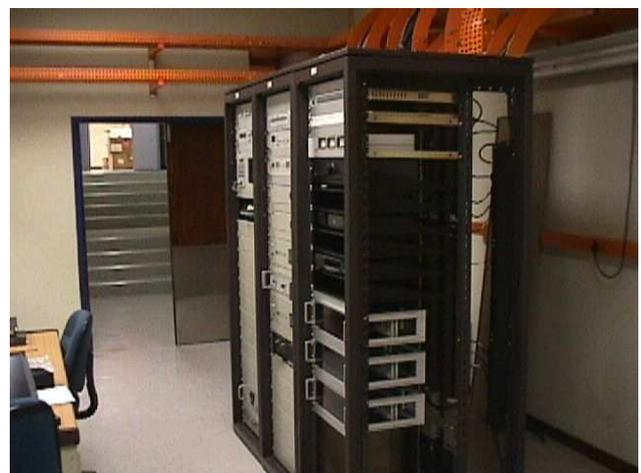
*Figure 3: Example of equipment installation. Note orange cable trays utilised for local equipotential bonding after their galvanic continuity was ensured.*

Particular attention was paid to internal equipotentialisation, using available natural components such as access floor and cable support infrastructure to achieve low impedance bonding. Refer *Figure 3*. In particular, great care was taken to implement galvanically solid bonding between cable tray sections, through cleaning of painted surfaces and implementation of new bonds across joints.

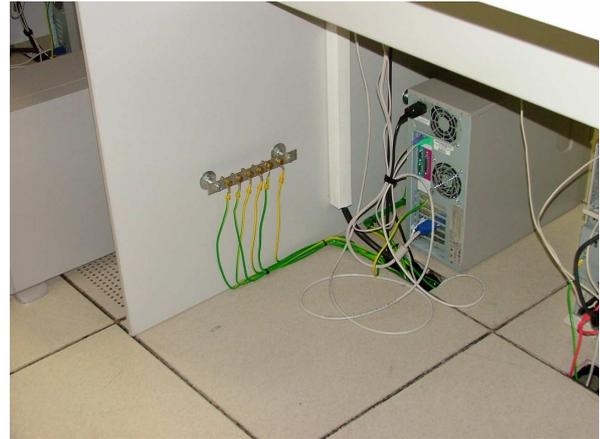
*Figure 4. This illustrates typical bonding between discrete servers and the access floor (whose galvanic continuity was ensured). Bonding was implemented via local bonding bars for maintenance convenience.*

At three of the sites where high speed data networks and sensitive electronic systems were installed, the broad band performance was enhanced through the establishment of a grid-like bonding network (using access flooring components, cable support structures, cabinets etc) to establish a ZSRG. All equipment, as well as the local bonding bars, was solidly connected to this ZSRG. Refer *Figure 4*.

The international financial institution highlighted this as a very significant intervention. It is important to note that a marked improvement in data network performance through a reduction in the data error rate was achieved through this approach.

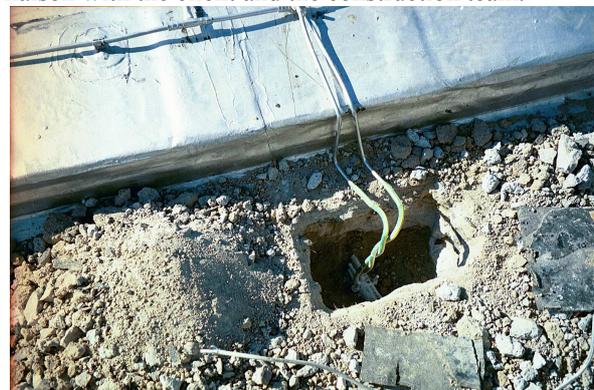
*Figure 5. Illustration of typical bonding of an air termination conductor to rebar on an existing structure. Sealing of bonds was given particular attention. The large hole was through non-structural cement screed (to then*

*access structural concrete and rebar through the smallest practical hole).*

Extensive use was made of natural components such as rebars, structural metalwork, cable support structures and down pipes because:

Refer *Figure 5*.
